# Test Report

<b>Name of Sample:</b>	Apollo Terminal
<b>Model No.:</b>	Apollo Terminal
<b>Client:</b>	PAYTER B.V.
<b>Manufacturer:</b>	PAYTER B.V.
<b>Test Sort:</b>	Commission Test
<b>Test Item:</b>	IK09

## Shenzhen EBO Testing Center

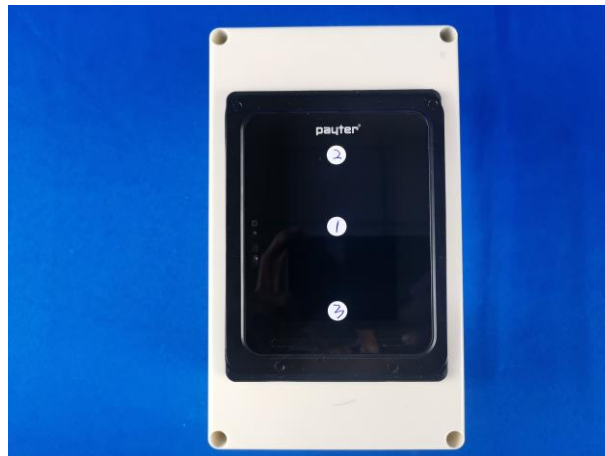
- (1) Place the sample on the ground, drop the pendulum bob which weight is 5kg to impact the sample from a height of 200mm, the impact energy is 10J
- (2) Impact 3 points on the surface of sample each for once

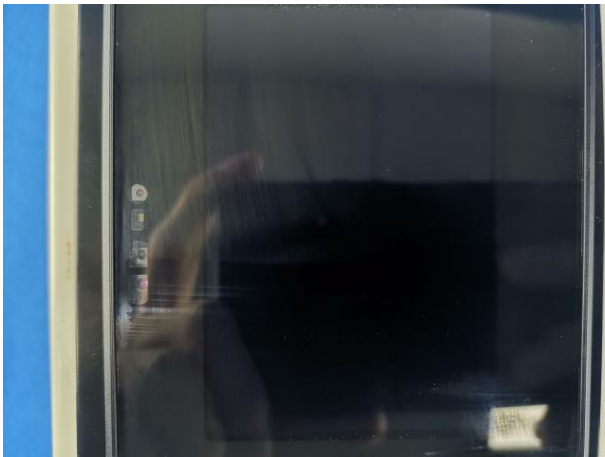
Visual check (Impact point 1)

After the test, the appearance of the sample is not broken, but the side corners have warped.  
(see after test Photos).

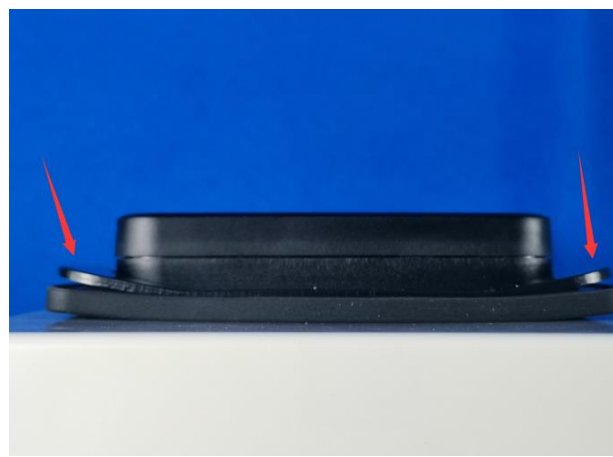
The side corners have warped.
